**THE STREAMBANK EROSION CONTROL
EVALUATION AND DEMONSTRATION ACT OF 1974
SECTION 32, PUBLIC LAW 93-251**

Appendix D - Ohio River Demonstration Projects

4. TITLE (and Subtitle) LITERATURE SURVEY AND PRELIMINARY EVALUATION OF STREAMBANK PROTECTION METHODS		5. TYPE OF REPORT & PERIOD COVERED Final report
6. AUTHOR(s) Malcolm P. Keown Elba A. Dardeau, Jr. Noel R. Oswalt Edward B. Perry		7. PERFORMING ORG. REPORT NUMBER

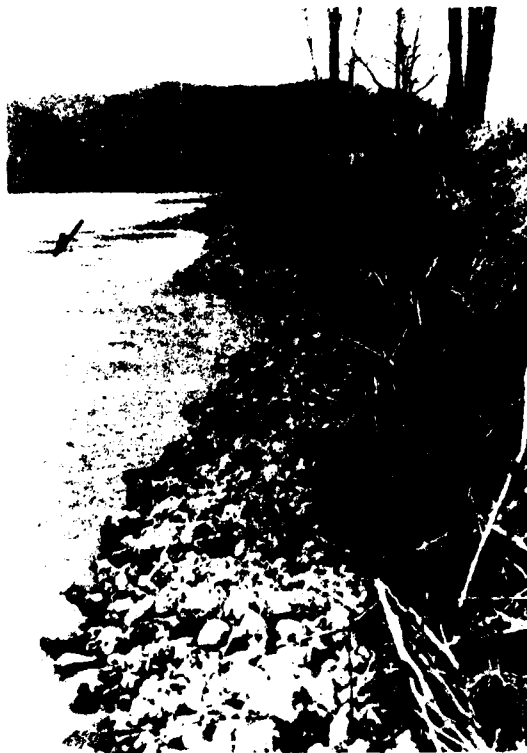
LOOKING UPSTREAM FROM
STA 27+50, NOTE HIGH
WATER DAMAGE TO UPPER
BANK. 24 MARCH 1978
